# Fatigue Life Assessment of Weld Surfacing of LB-52 Solid Wire on SCM 440 Alloys Steel Propeller Shafts

**Abstract**—The damage to the propeller shaft, a principal mechanical component in the power transmission system of the Kolek Boats makes engines work harder than normal attributed to less transmission efficiency. Operating boats with the damaged propeller shaft increases the rate of fuel consumption per distance and cost of fishing which affects income of coastal fishermen. The result of a preliminary survey of Cut-Stern Kolek Boats at Kaoseng Community revealed that the service life of the damaged propeller shafts caused by the fatigue failure would be repaired by shield metal arc welding process. The statistical analysis showed that the useful life depended on fatigue endurance limit of welding surface. When they were back to be used again. The objective of this research was to study the fatigue life of hardfacing surface LB-52 solid wire. The method of this research included (a) building up the hardfacing surface (b) forming specimen from hardfacing surface and (c) finding out the fatigue life by fatigue testing machine base on ASTM E739-91 standard. The results of this re

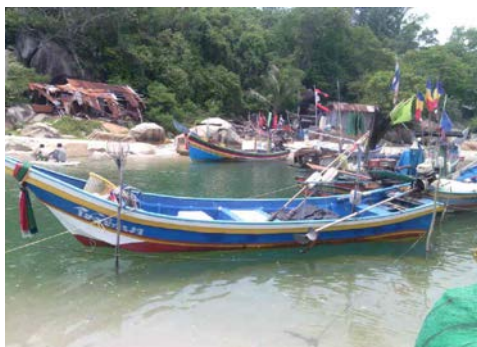
Fig. 1. The cut-stern kolek boats.

The popular southern local fishing boats are the Kolek boats which are modified by the presence of engines and long tail shaft at the cut-stern. A traditional Kolek boat then becomes a cut-stern Kolek boat, as shown in Fig. 1.

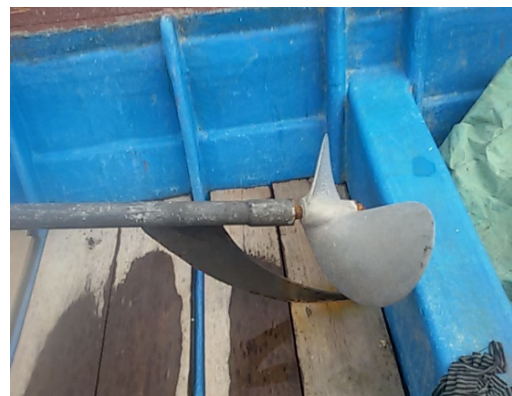
Fig. 2. Propeller shafts.

The cut-stern Kolek were driven by using driving forces from engines. The propeller shaft, as shown in Fig. 2, was the part of main machine in the transmission system of the cut-stern Kolek [3]. While the boat is being used, the shaft works all the time. The shaft receives cyclic loads continuously, which it has a high statistical damaged rate from fatigue mechanism. Welding resurfacing by using shielded metal arc welding process is the current welding repair technique [4], [10]. Some propeller shafts can only be used shortly, while others may last for a long time, since the fatigue life was limited by the weld metals' hardness from the information and reason above, this research aims to investigate the fatigue life of hardfacing surface of LB-52 propeller shafts.

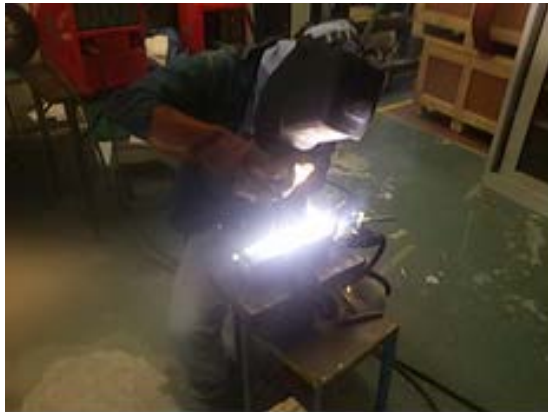
Fig. 3. Shielded metal arc welding.

The SCM 440 alloy steels were formed as c-shape with 3 inches cross-sectional area. The chemical compositions and mechanical properties of SCM 440 alloy steels are shown in Table I and II. After that, the specimens were cut into 18 pieces. Each specimen has a length of 30 cm. Then, the inner surface of c-shape channel was hardfaced by using shielded metal arc welding, as shown in Fig. 3, with 4mm LB-52

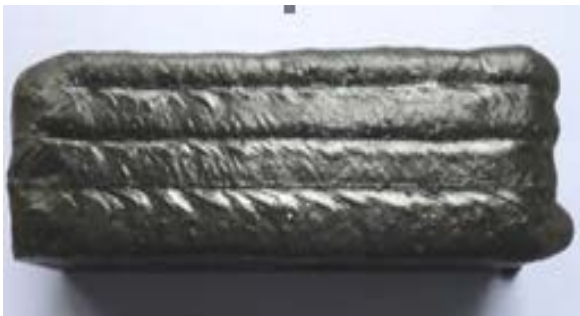
Fig. 4. Hardfacing surface.

coated electrodes. The height of hardfacing surface is 20 mm, as shown in Fig. 4. The beads were deposited in zigzag patterns. Electrodes were baked at 350°C for half hour, but there is no preheat and post weld heat treatment. The chemical compositions of welding electrodes are shown on Table III. LB-52 is a basic coated low hydrogen electrode suitable for welding heavy structures, high tensile strength jobs where impact strength at sub-zero temperatures are required. The basic coated formulation ensures a defect-free radiographic quality weld. The superb and well established flux formulation ensure excellent performance of the electrode in AC/DC (+) in all welding positions except vertical down.

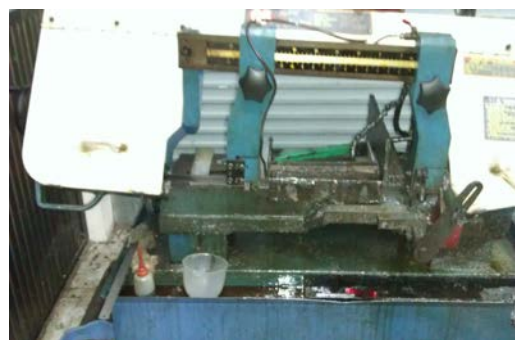
Fig. 5. Cutting with square-band saw.

Twenty pieces of hardfacing surface of LB-52 were taken for cutting with 12.5 mm width  $\times$  226 mm length square-band saw, as shown in Fig. 5 and 6. Sixty pieces of specimens were obtained after cutting.

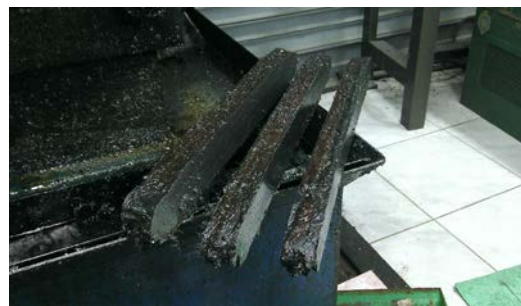
Fig. 6. Specimen after cutting.

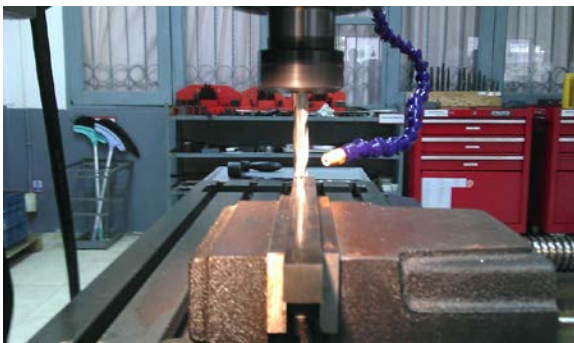
Fig. 7. Face milling the specimens.

Then, face milling the specimens was conducted, as shown in Fig. 7. The specimens were lathed, as illustrated in Fig. 8, to obtain the diameter of 12.18 mm and length of 226 mm. Both ends were dropped off shoulders at 1 mm with 45 degree angle. At 65 mm from both ends, the fillets of 30 degree angle were created, as shown in Fig. 9. Lastly, the specimens were polished to obtain the smooth and shiny surface before testing as shown in Fig. 10.

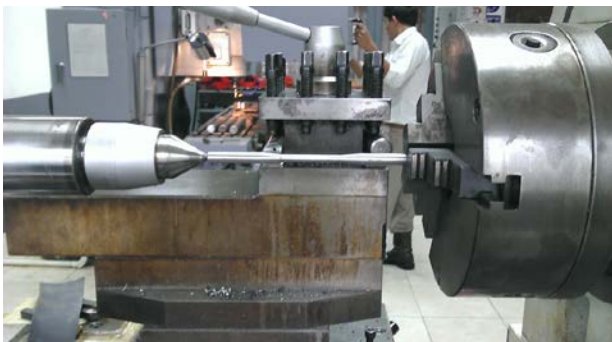
Fig. 8. Lathed the specimens.

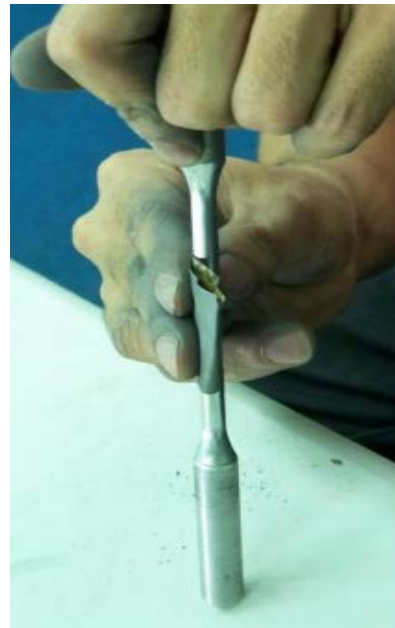
Fig. 10. Surface polishing.
